Entry to the Stockholm Junior Water Prize – 2013 Hungary

THE IMPORTANCE OF THE SZINVA-STREAM BIOLOGICAL AND CHEMICAL-PHYSICAL EXAMINATIONS

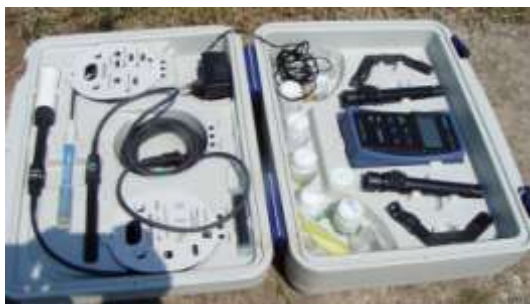
MultiLine 3430 (WTW) – digital device for environmental measurements

Tetracon 925 – conductivity-,

FDO 925 – oxygen-,

IDS pH-measuring sensor

VISOCOLOR ECO PF-12 photometric environmental trunk (MN)

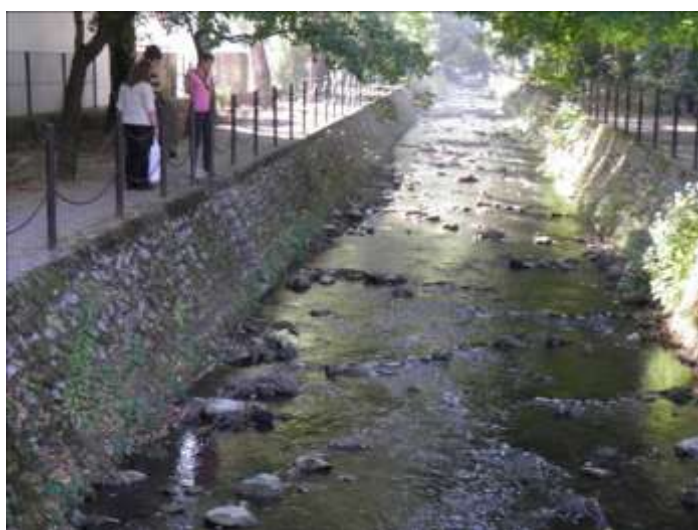
1st measuring point: Waldorf School – Felso-Hamor

Fairly unspoilt part of the upper-Szinva. The quality of water is considered to be excellent here. Loading from part of the inhabitants cannot be seen. Only the joining Garadna stream brings in some pollution. In 2012 smaller nitrite and phosphate pollutions could be observed (1st chart). Sewage is not flowing into it. The watercourse is clean and clear, the stream is fast flowing.

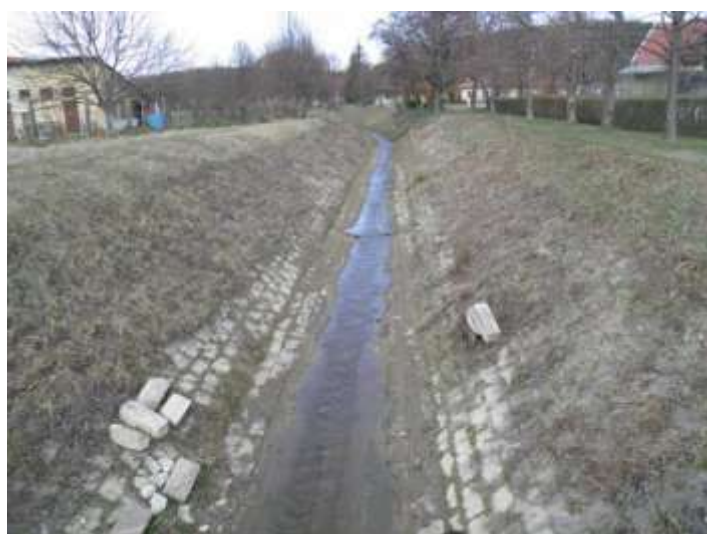
2nd measuring point: Bridge of the Hovirag road

At this measuring point the quality of water degrades a little but remains good. This part is highly urbanised. Loading of the inhabitants is present but low. After the flood of 2010 the local-government rebuilt the watercourse, which is clean just like the banks.

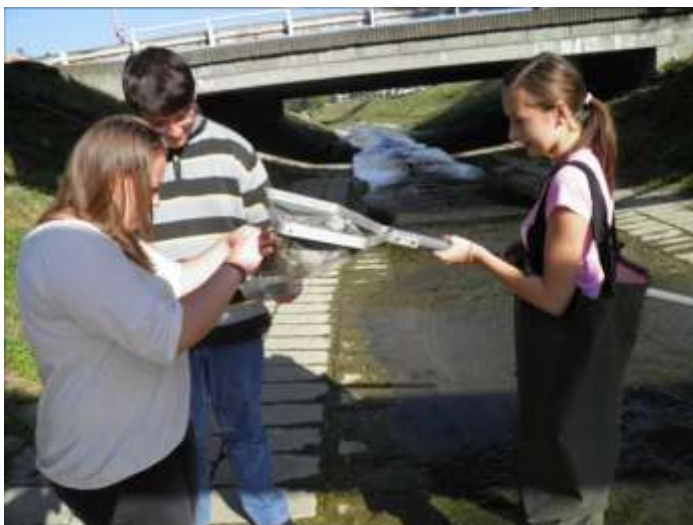
3rd measuring point: Bridge of the Vasgyar road

Above the measuring point three smaller streams join the Szinva: the Pereces, the Tatar-arok and the Lyuko. These ones bring in most of the pollutions. According to the data this point is considered to be between the 3rd and 4th class. The solution for this problem is to clean the mentioned three streams.

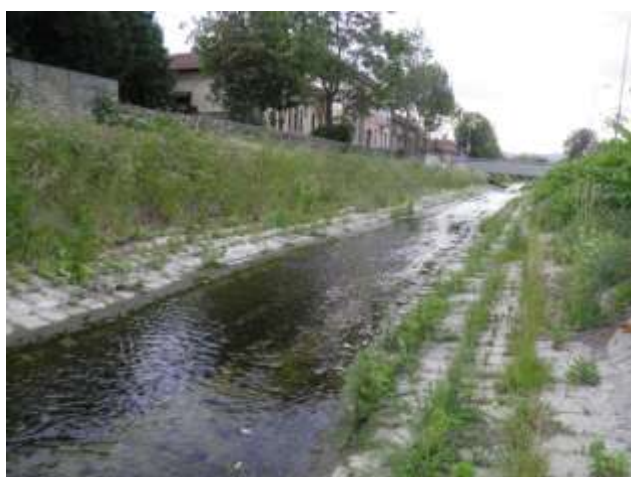
4th measuring point: Ambulance station

This measuring point is quite new as we included it only in 2011 first. Through these results we wanted to know if the self-purification of the Szinva was effective in the green zone in which it flows between the 3rd and 4th measuring points.

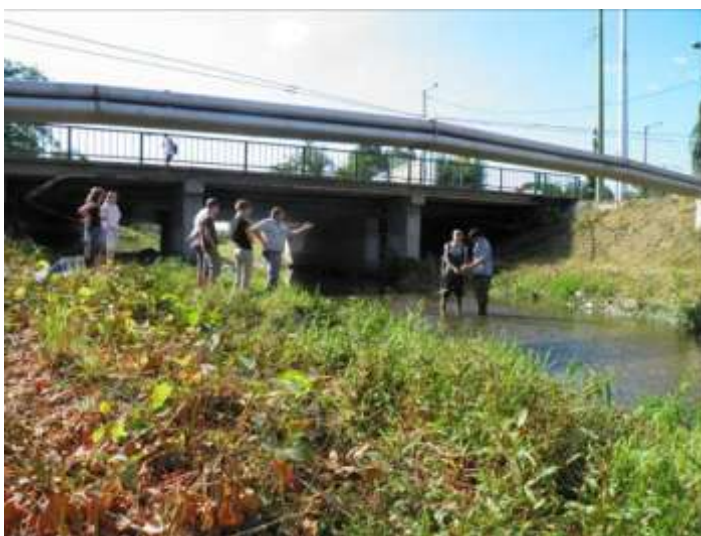
5th measuring point: Bridge of the Hutohaz road

At the last measuring point the Szinva maintained the pollution caused at the Vasgyar throughout the whole year. As the runoff is little it was unable to dilute it.

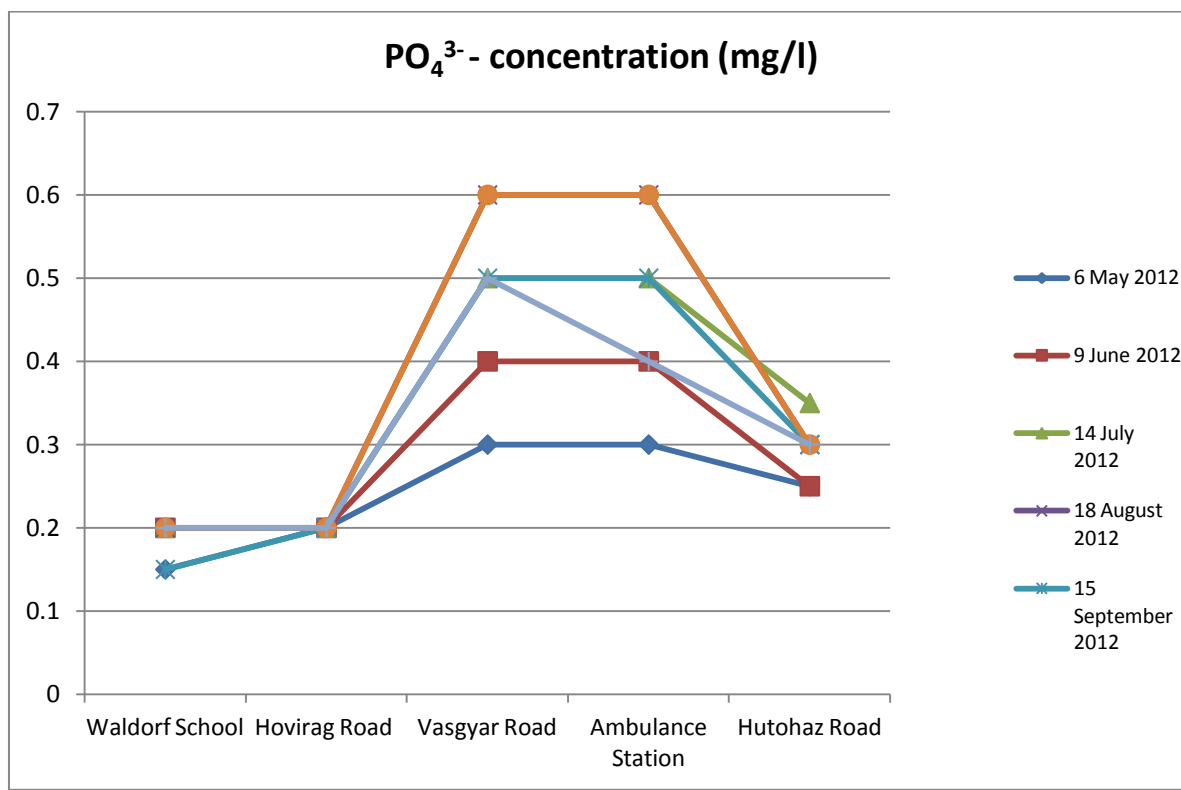
1st diagram

The presence of the phosphate-ion is obviously the result of human activities: industrial sources, for example, or it refers to the presence of sewage. After the clean and clear upper-part there are sudden peaks from the 3rd measuring point.

High concentration favours plants and algae in water thus sluggish water could appear which might lead to eutrophication. We found a lot of them in 2012.

As it is clear from the 1st diagram, the most worrying extent of pollution is at the 3rd measuring point where the three mentioned smaller streams join together. The results are almost the same as at the ambulance station. Before the firth the concentration gets lower but still does not reach the level of the upper part. According to the examinations of 2012 the self-purification of the Szinva falls behind compared to the past years. The reason for this is the decrease of the amount of annual rainfall.

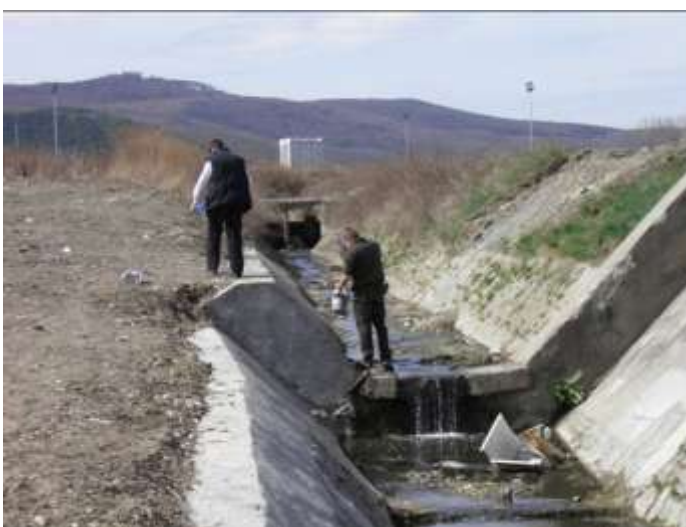
6th measuring point: Firth of the Perces-stream

The Perces-stream has been cleaned several times since 2009. The watercourse is visible. The deep muddy parts have also been cleaned. As a result the quality improved a bit, but the water coming from the mine still has huge conductivity.

The constantly high nitrite-, nitrate and phosphate-ion concentration allows us to think that sewage is led to the water. The state of the stream has not been changed

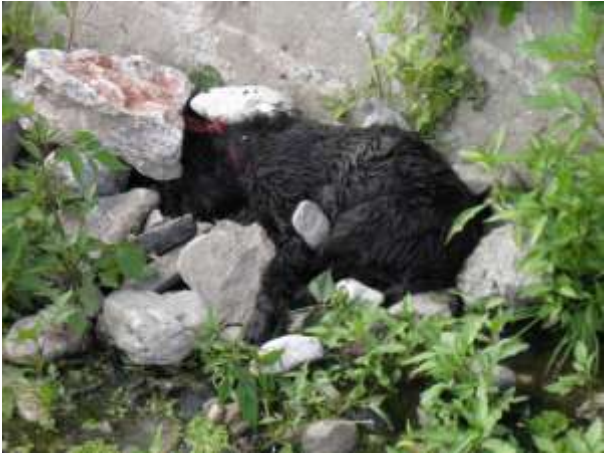
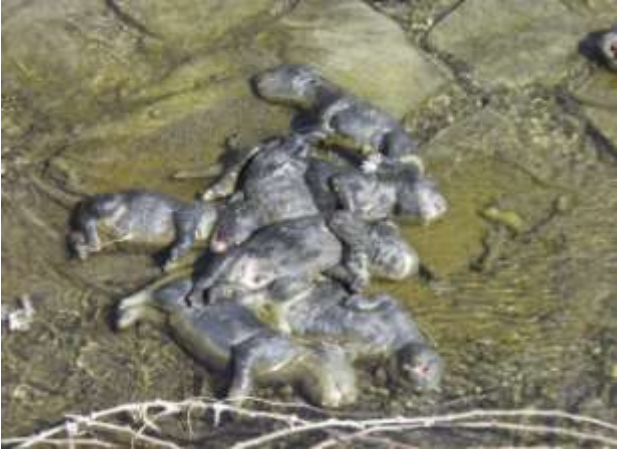
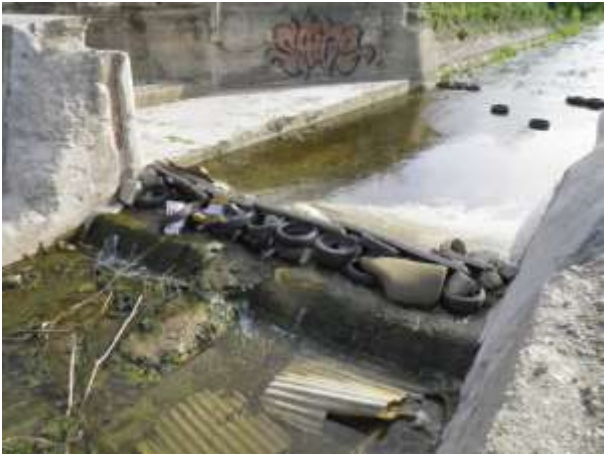
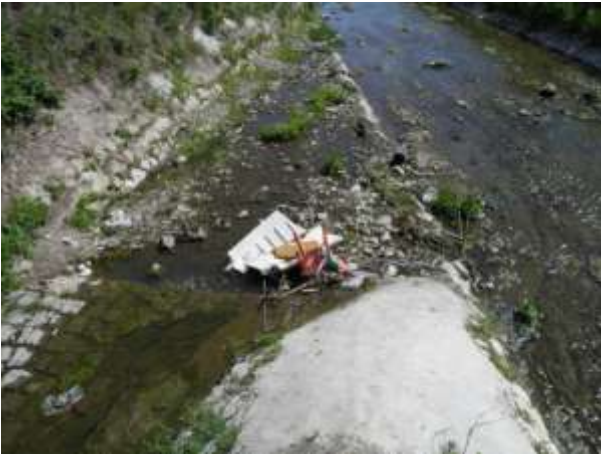
Unfortunately the area is very loaded by means of human activity. At a specific part of the area we were able to see the traces of animal torture, for example, and a lot of garbage was thrown into or near the water. See the pictures below.

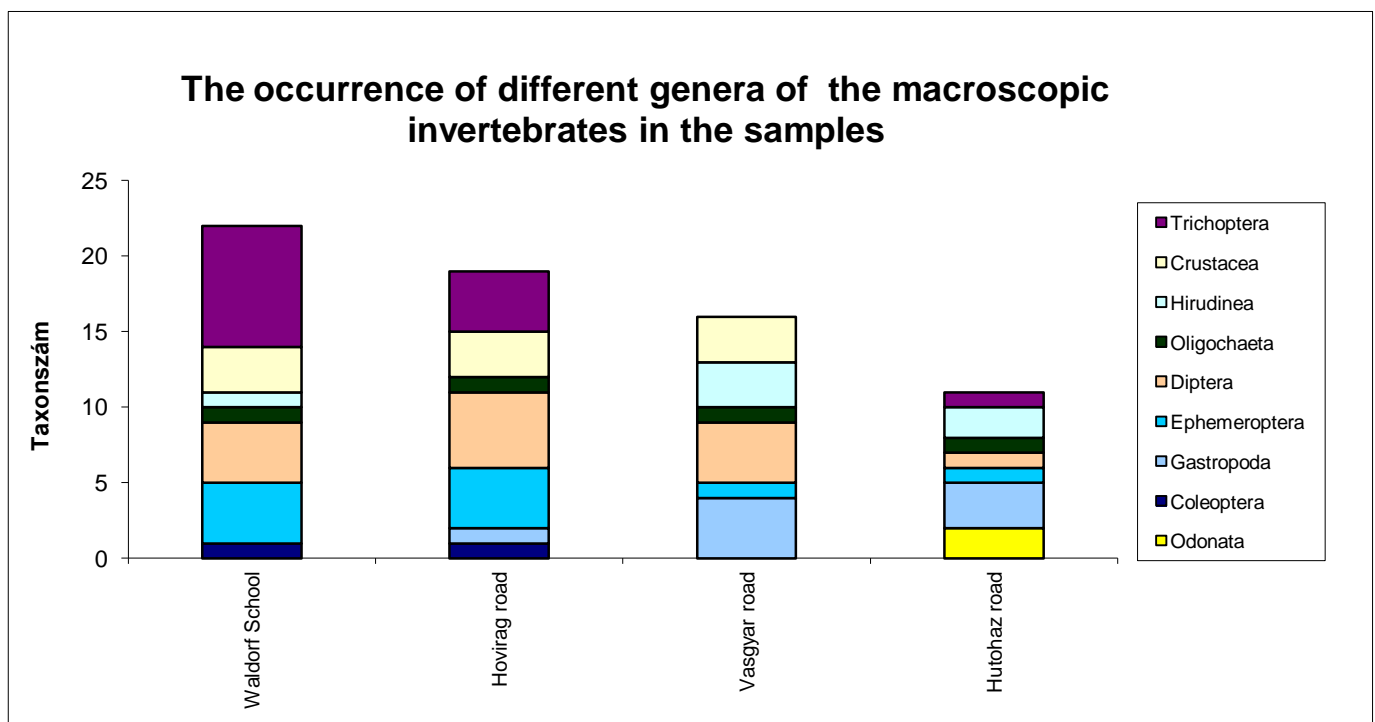
2nd diagram

The Results of the Samples from May

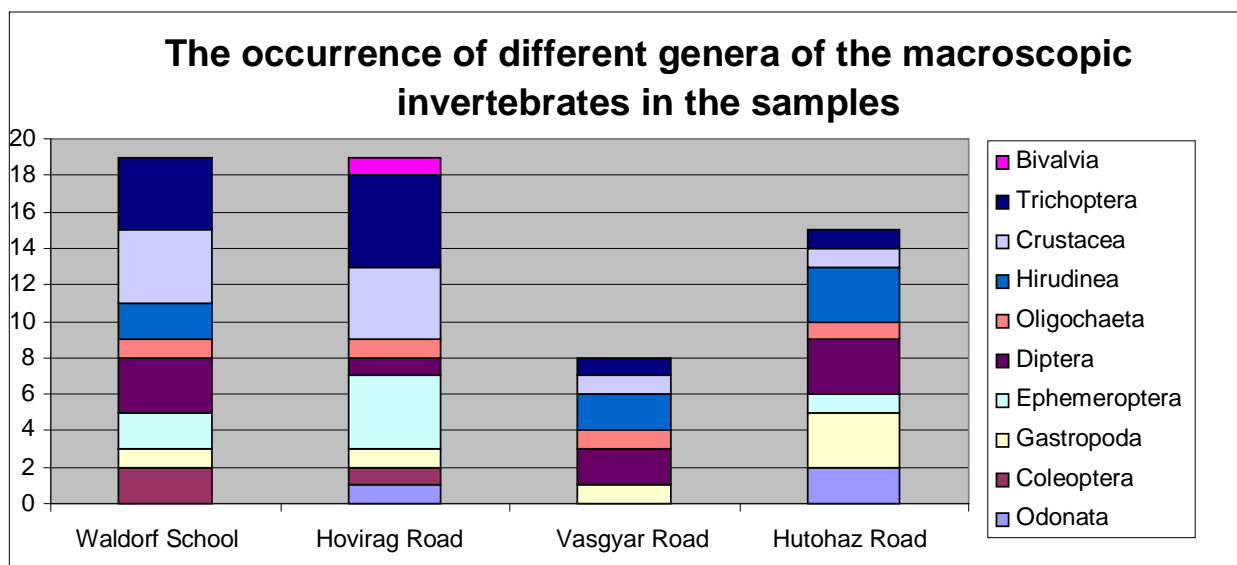
3rd diagram

The Results of the Samples from October
